## MI Heating Cable – Typical Trench Drain Cross Section

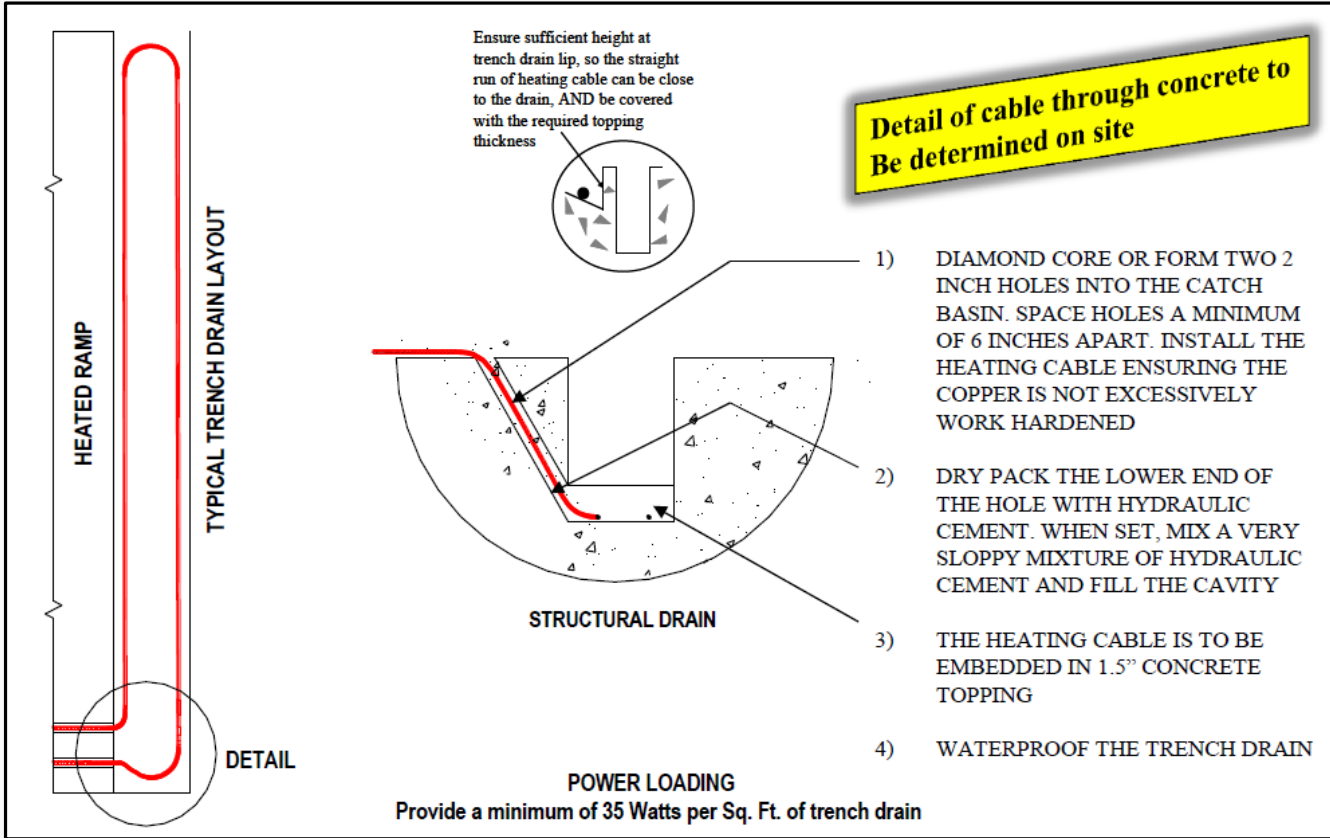
1. The Hole/Cavity MUST be completely filled with cement, to avoid air pockets around the heating cable. Failure to do this will result in early burnout of the heating cable. This is EXTREMELY IMPORTANT.
2. If the trench drain heating cable replacement is part of a ramp reconstruction – first remove the existing topping and heating cables
